# Walk Around

## Focke-Wulf Fw 190A/F

Walk Around Number 22  
squadron/signal publications

By Malcolm Laing and E. Brown Ryle

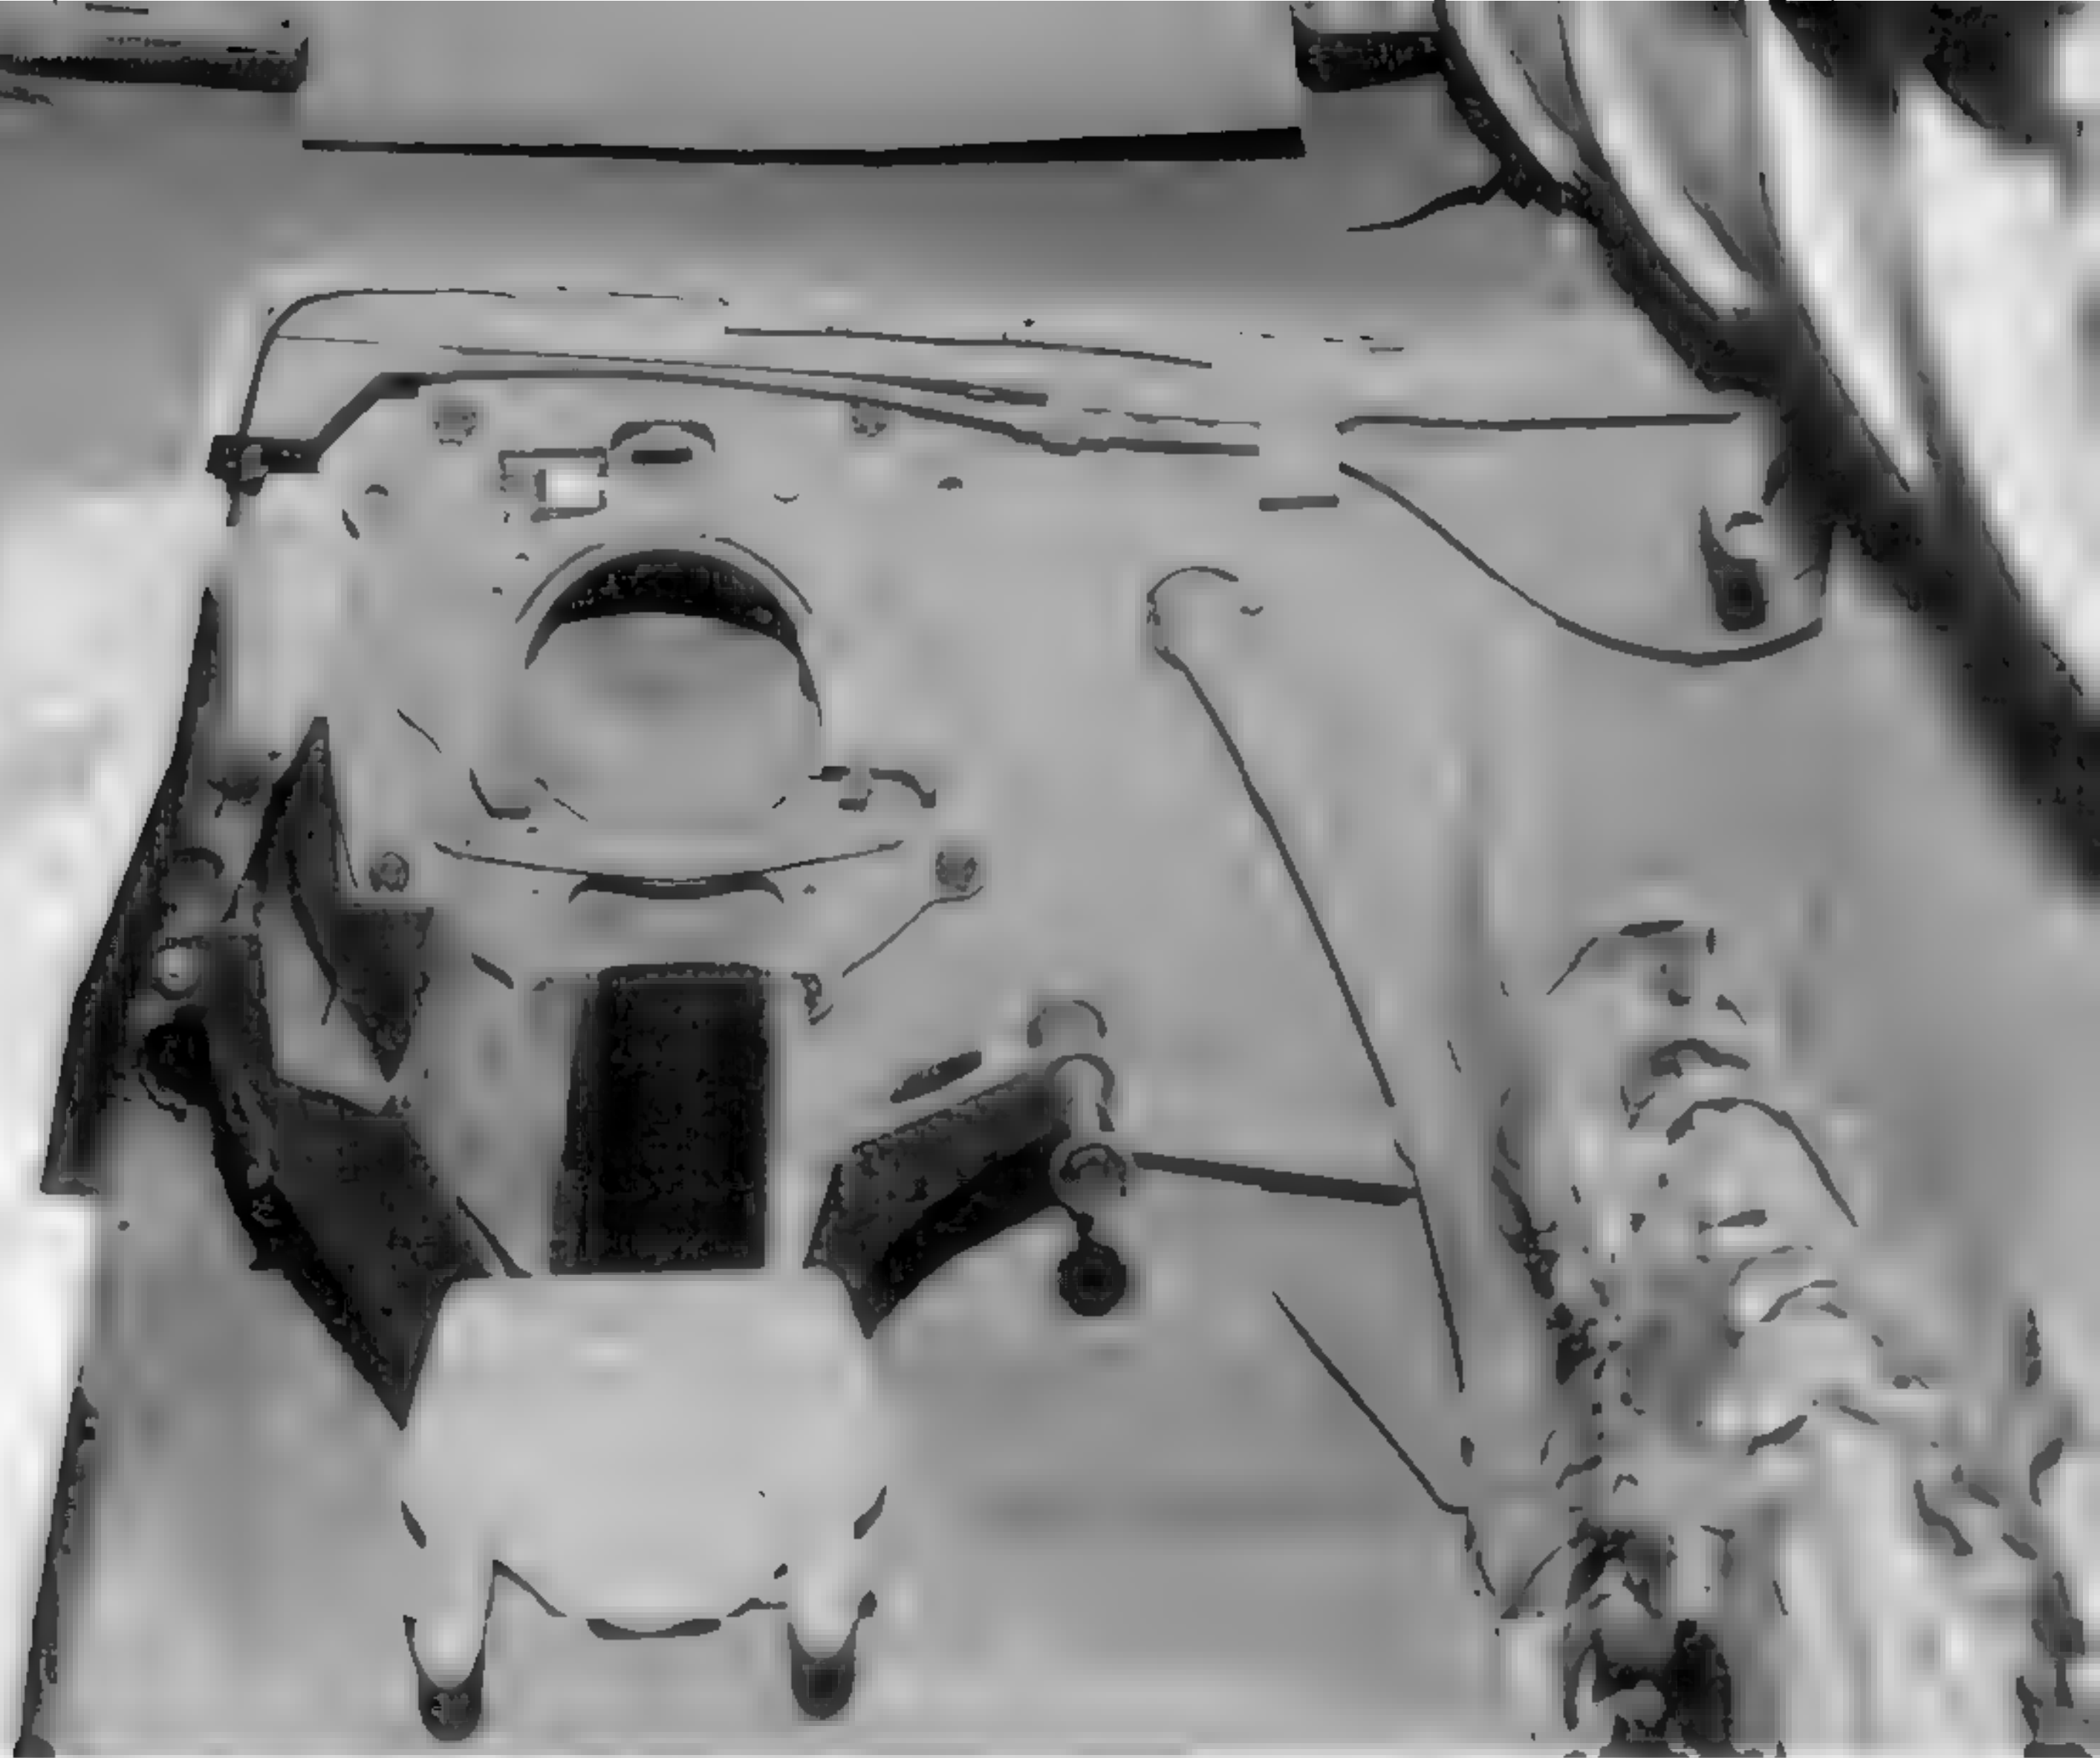
The port wing-root 20mm MG151 cannon has been removed from this Fw 190A-6; however, the mounting unit has been left in place. The forward gun support bracket is mounted on the front wall of the gun bay. The cannon's barrel passed through the hole extending through the main wing spar into the wheel well. (Molnar & Hugo)

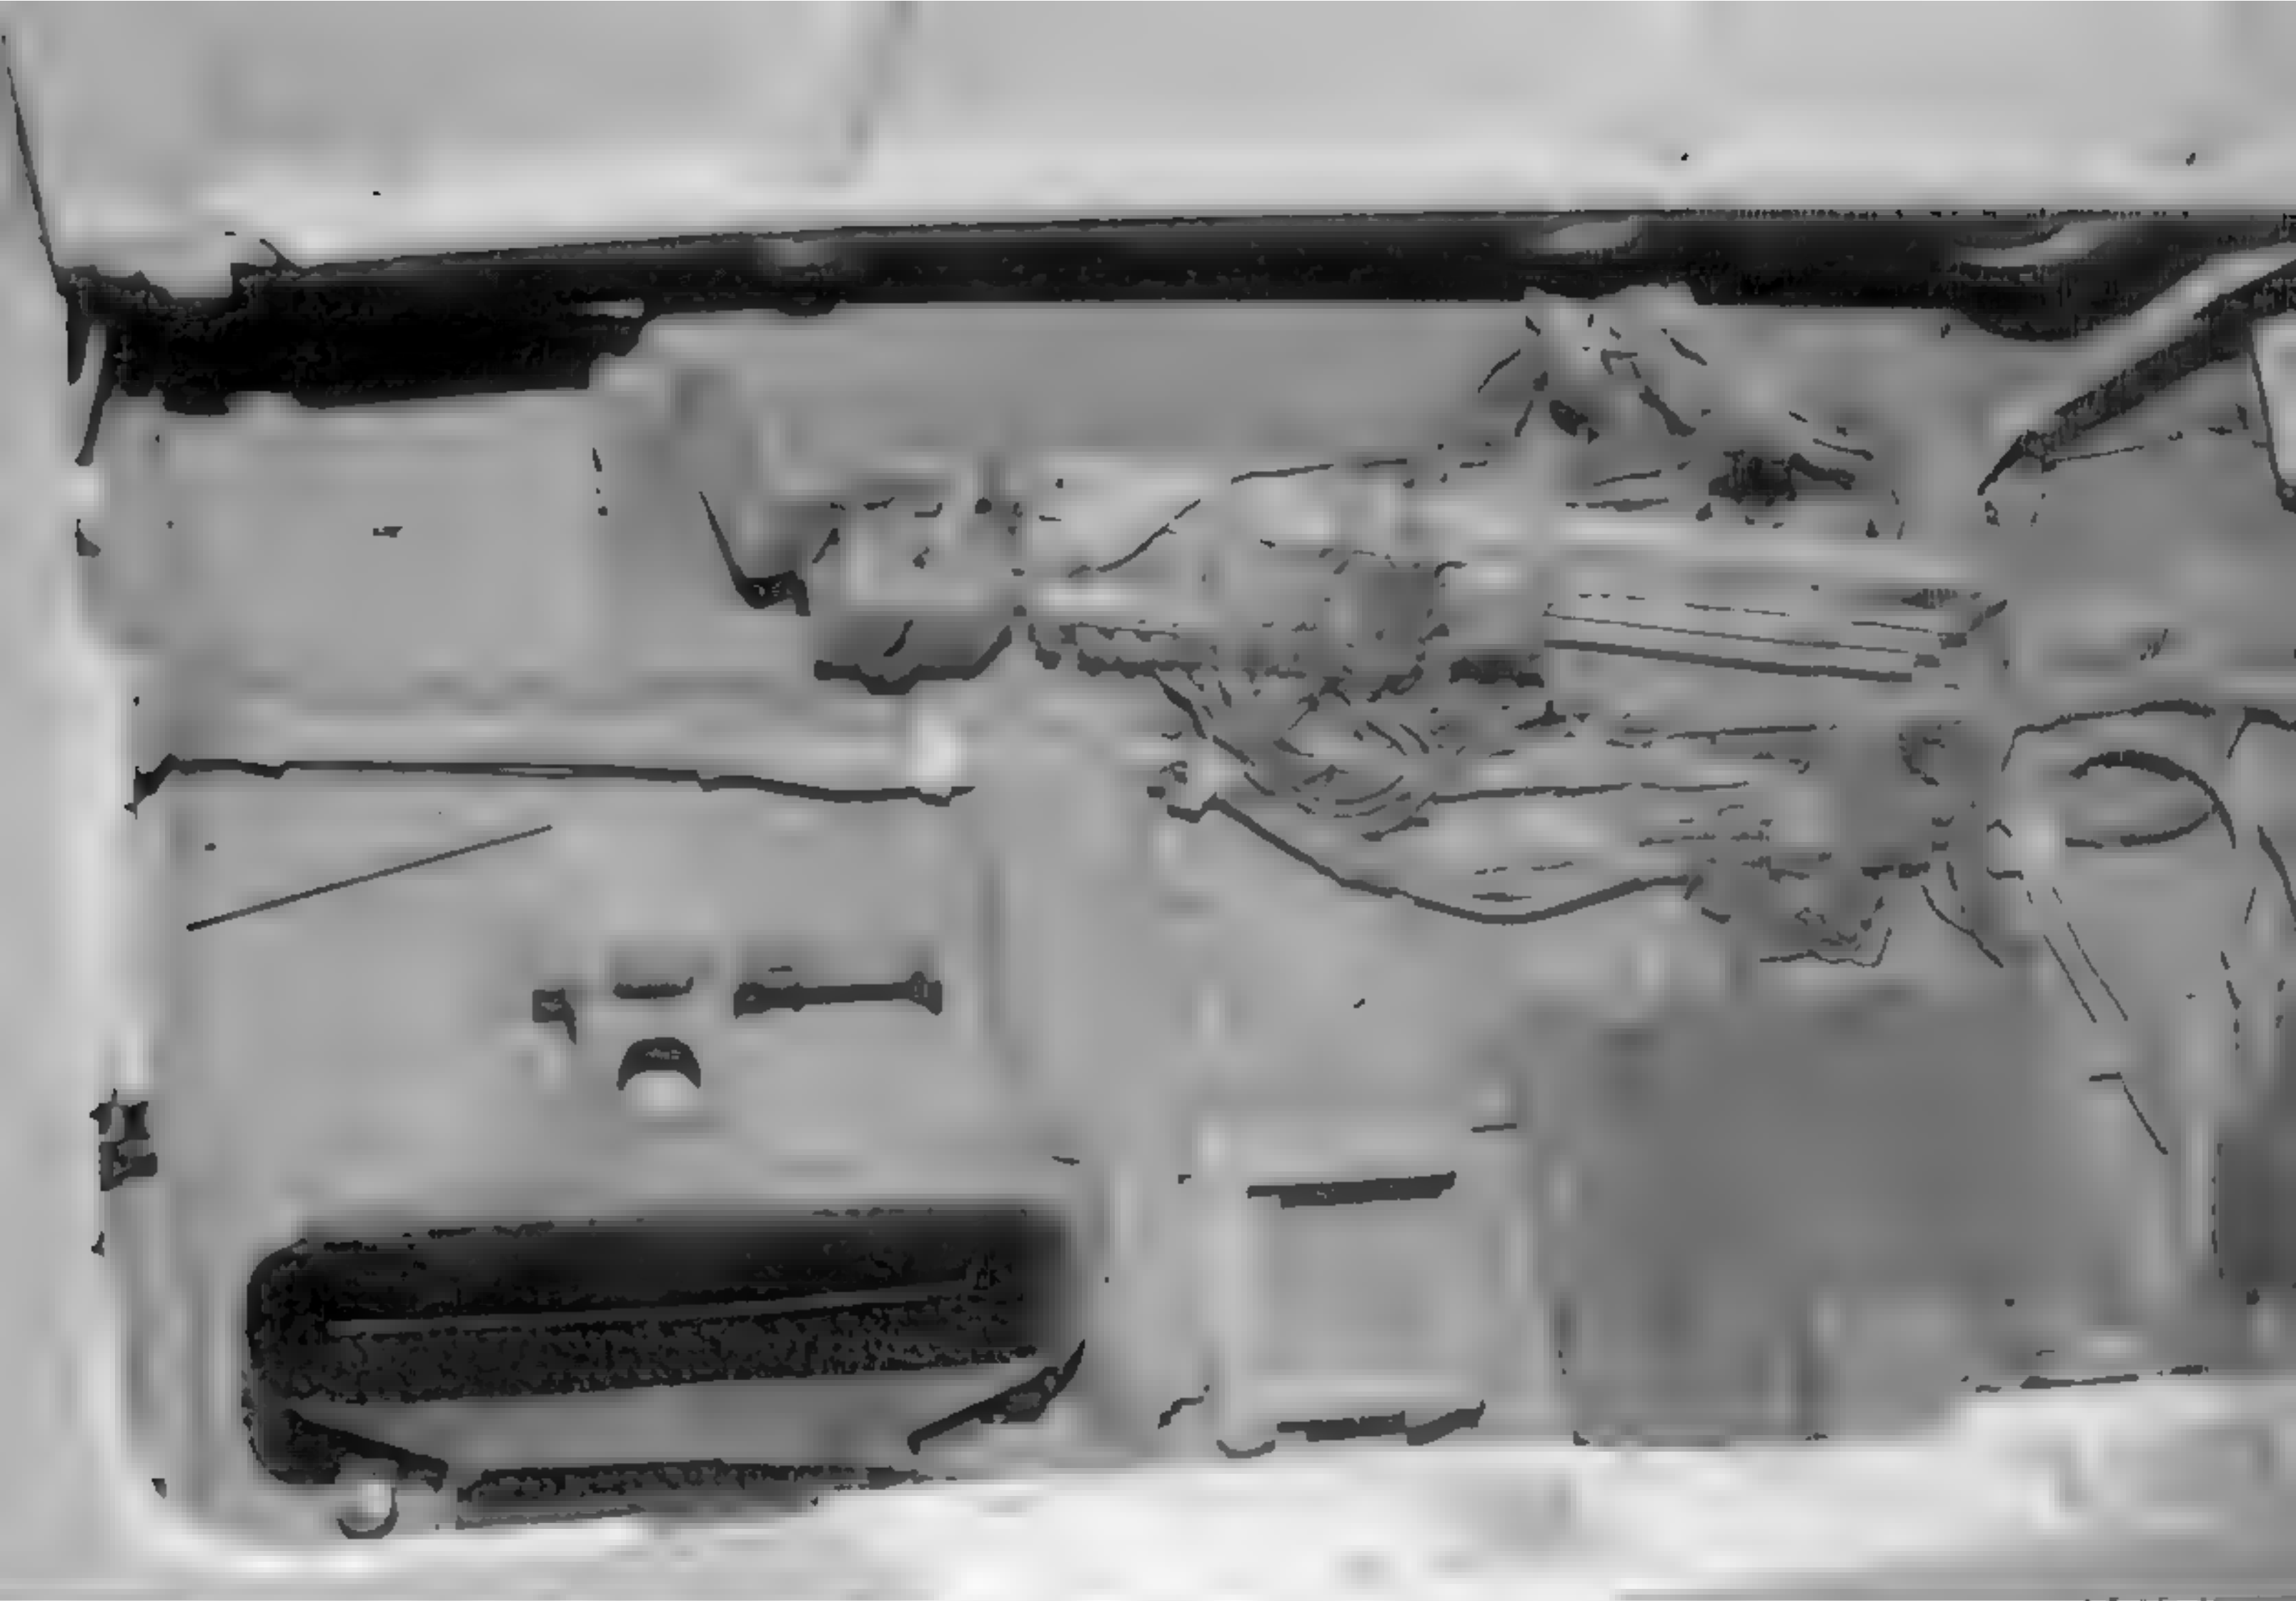
An opening beneath the port wing-root gunbay door hinge led to the fuselage ammunition storage bin. The 250 rounds of 20MM linked ammunition passed from this bin through the opening to the weapon. Spent cannon shells were ejected through the wing bottom via the dual link-belt/cartridge case chute. The cannon's electrical firing system wiring is just aft of the EDSK-B1 distributor box. The rear wing spar composed the aft wall of the gun bay.

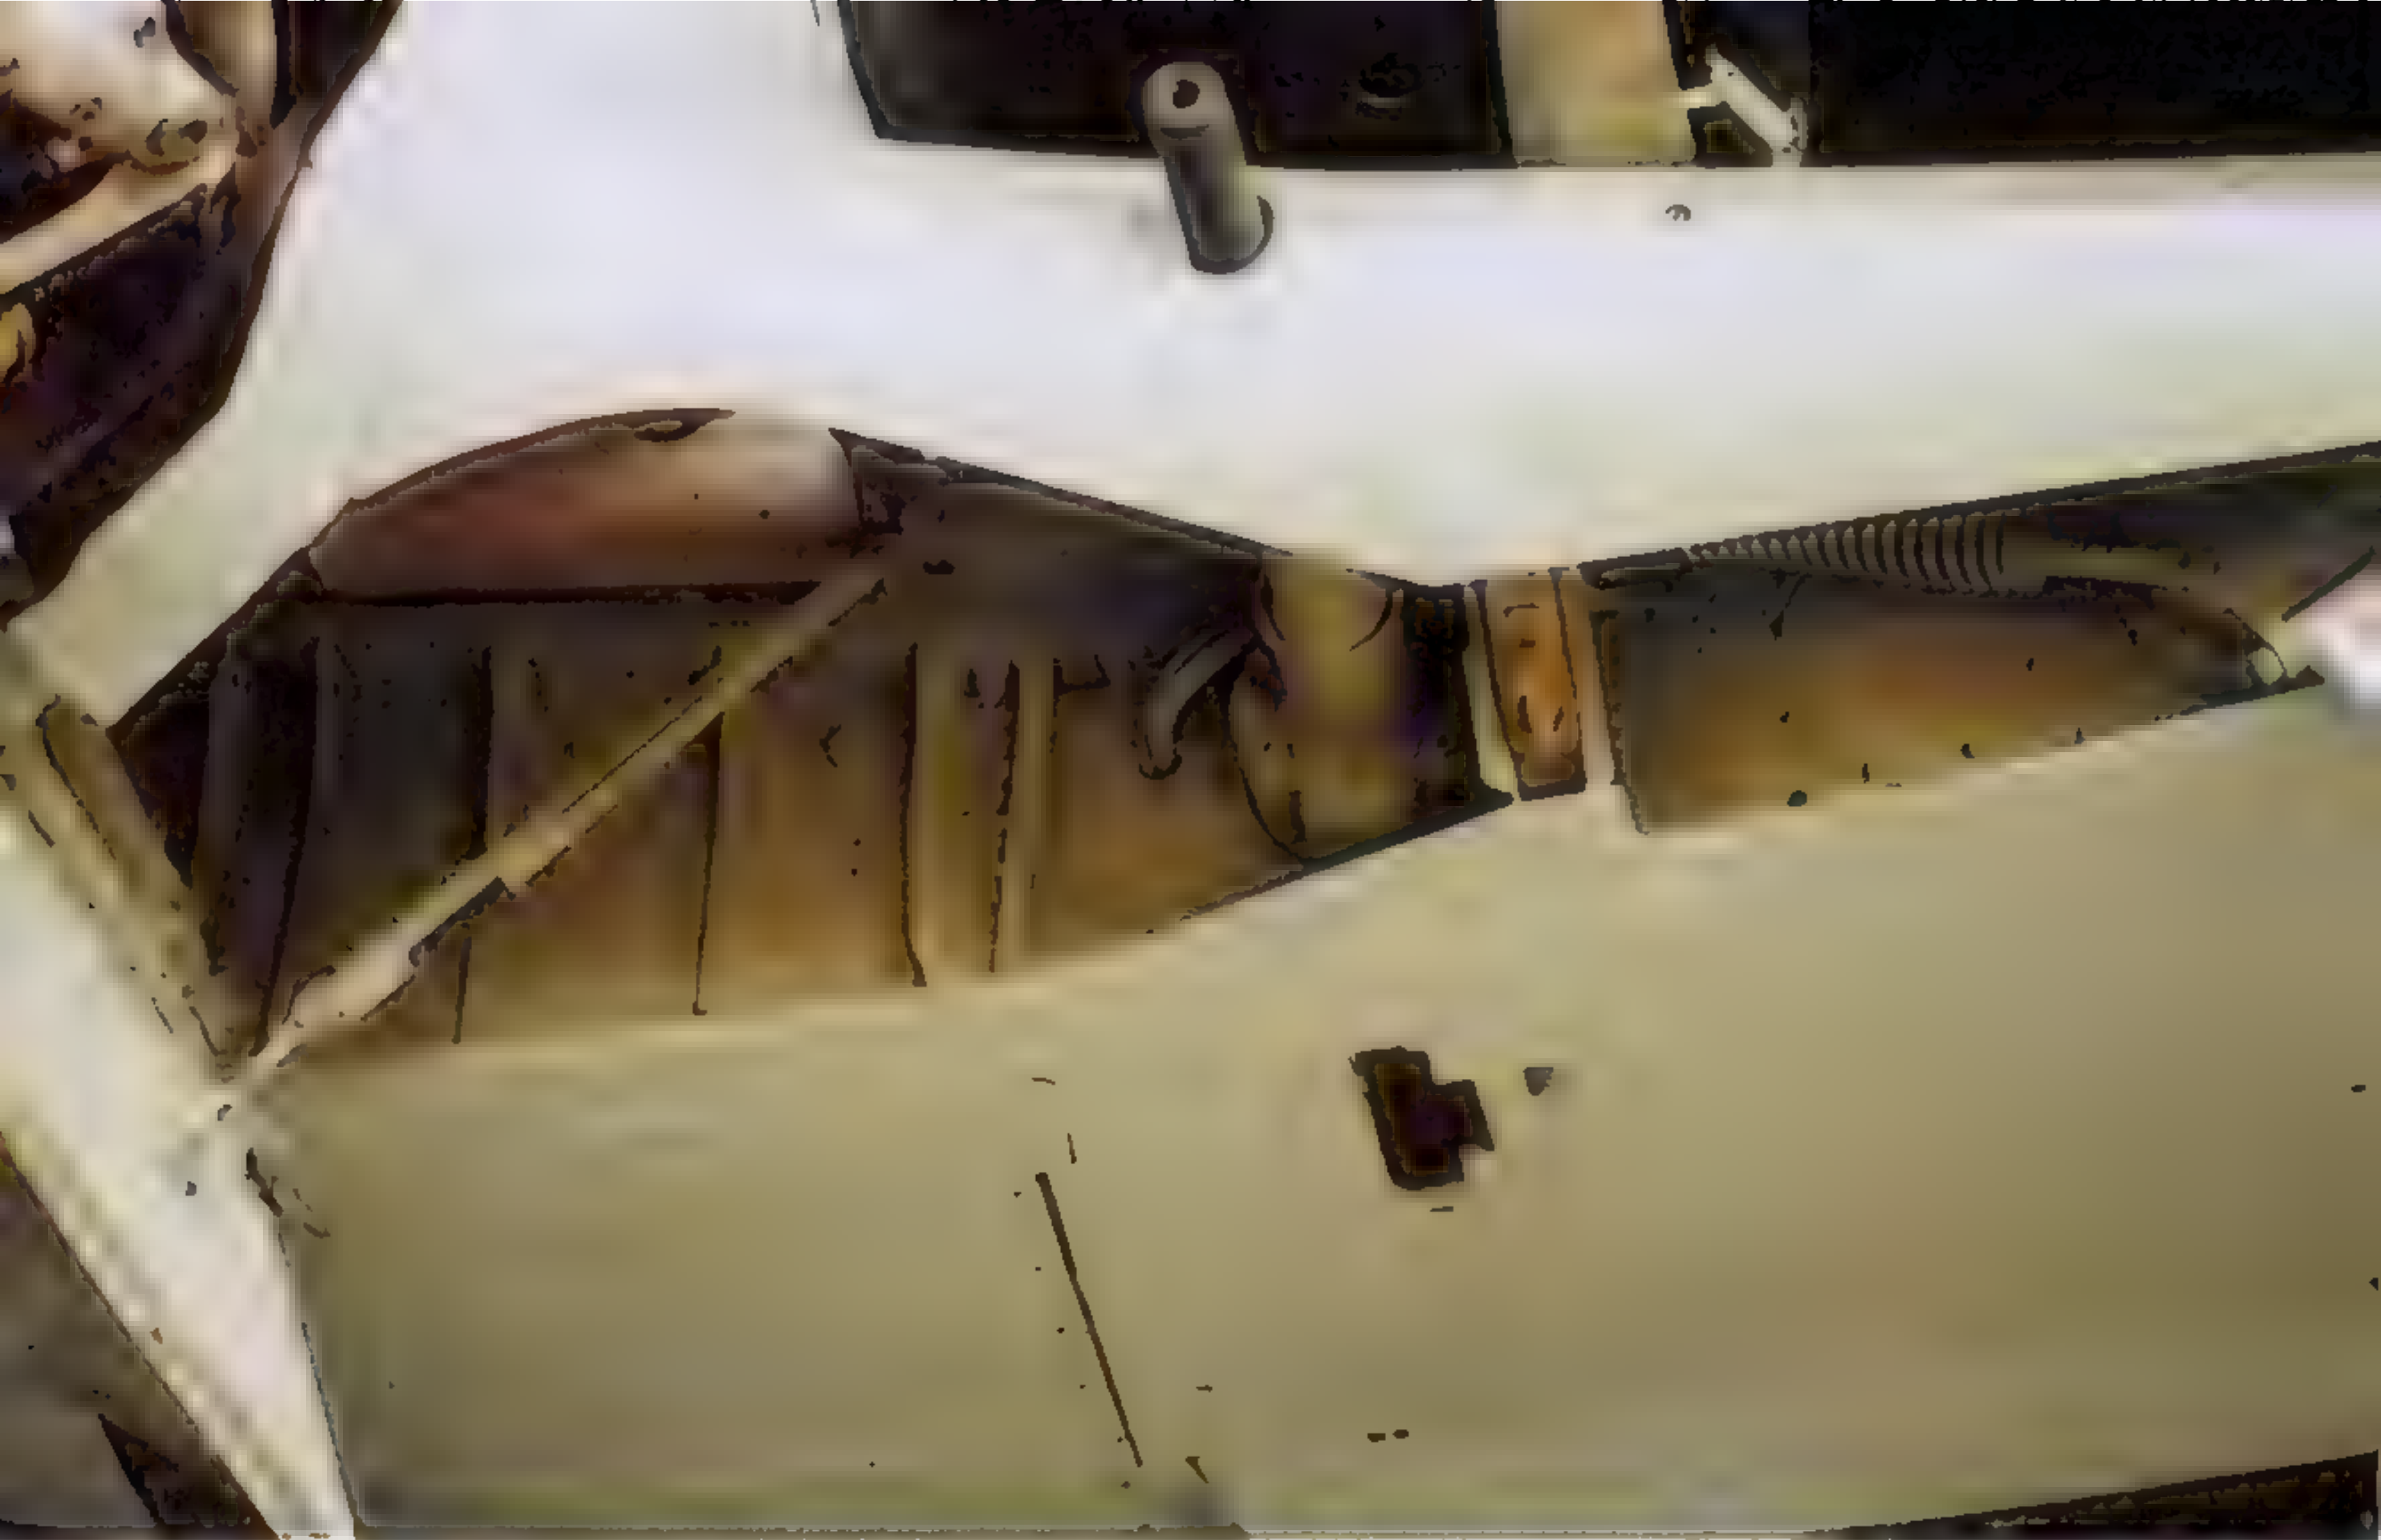
The rectangular slot aft the port main wheel well is the ejection chute for spent 20MM cartridges. The blast tube containing the cannon's barrel runs through the wheel well directly above the ejection chute. A retraction strut connects the inboard landing gear door to the wheel well. (Molnar & Hugo)

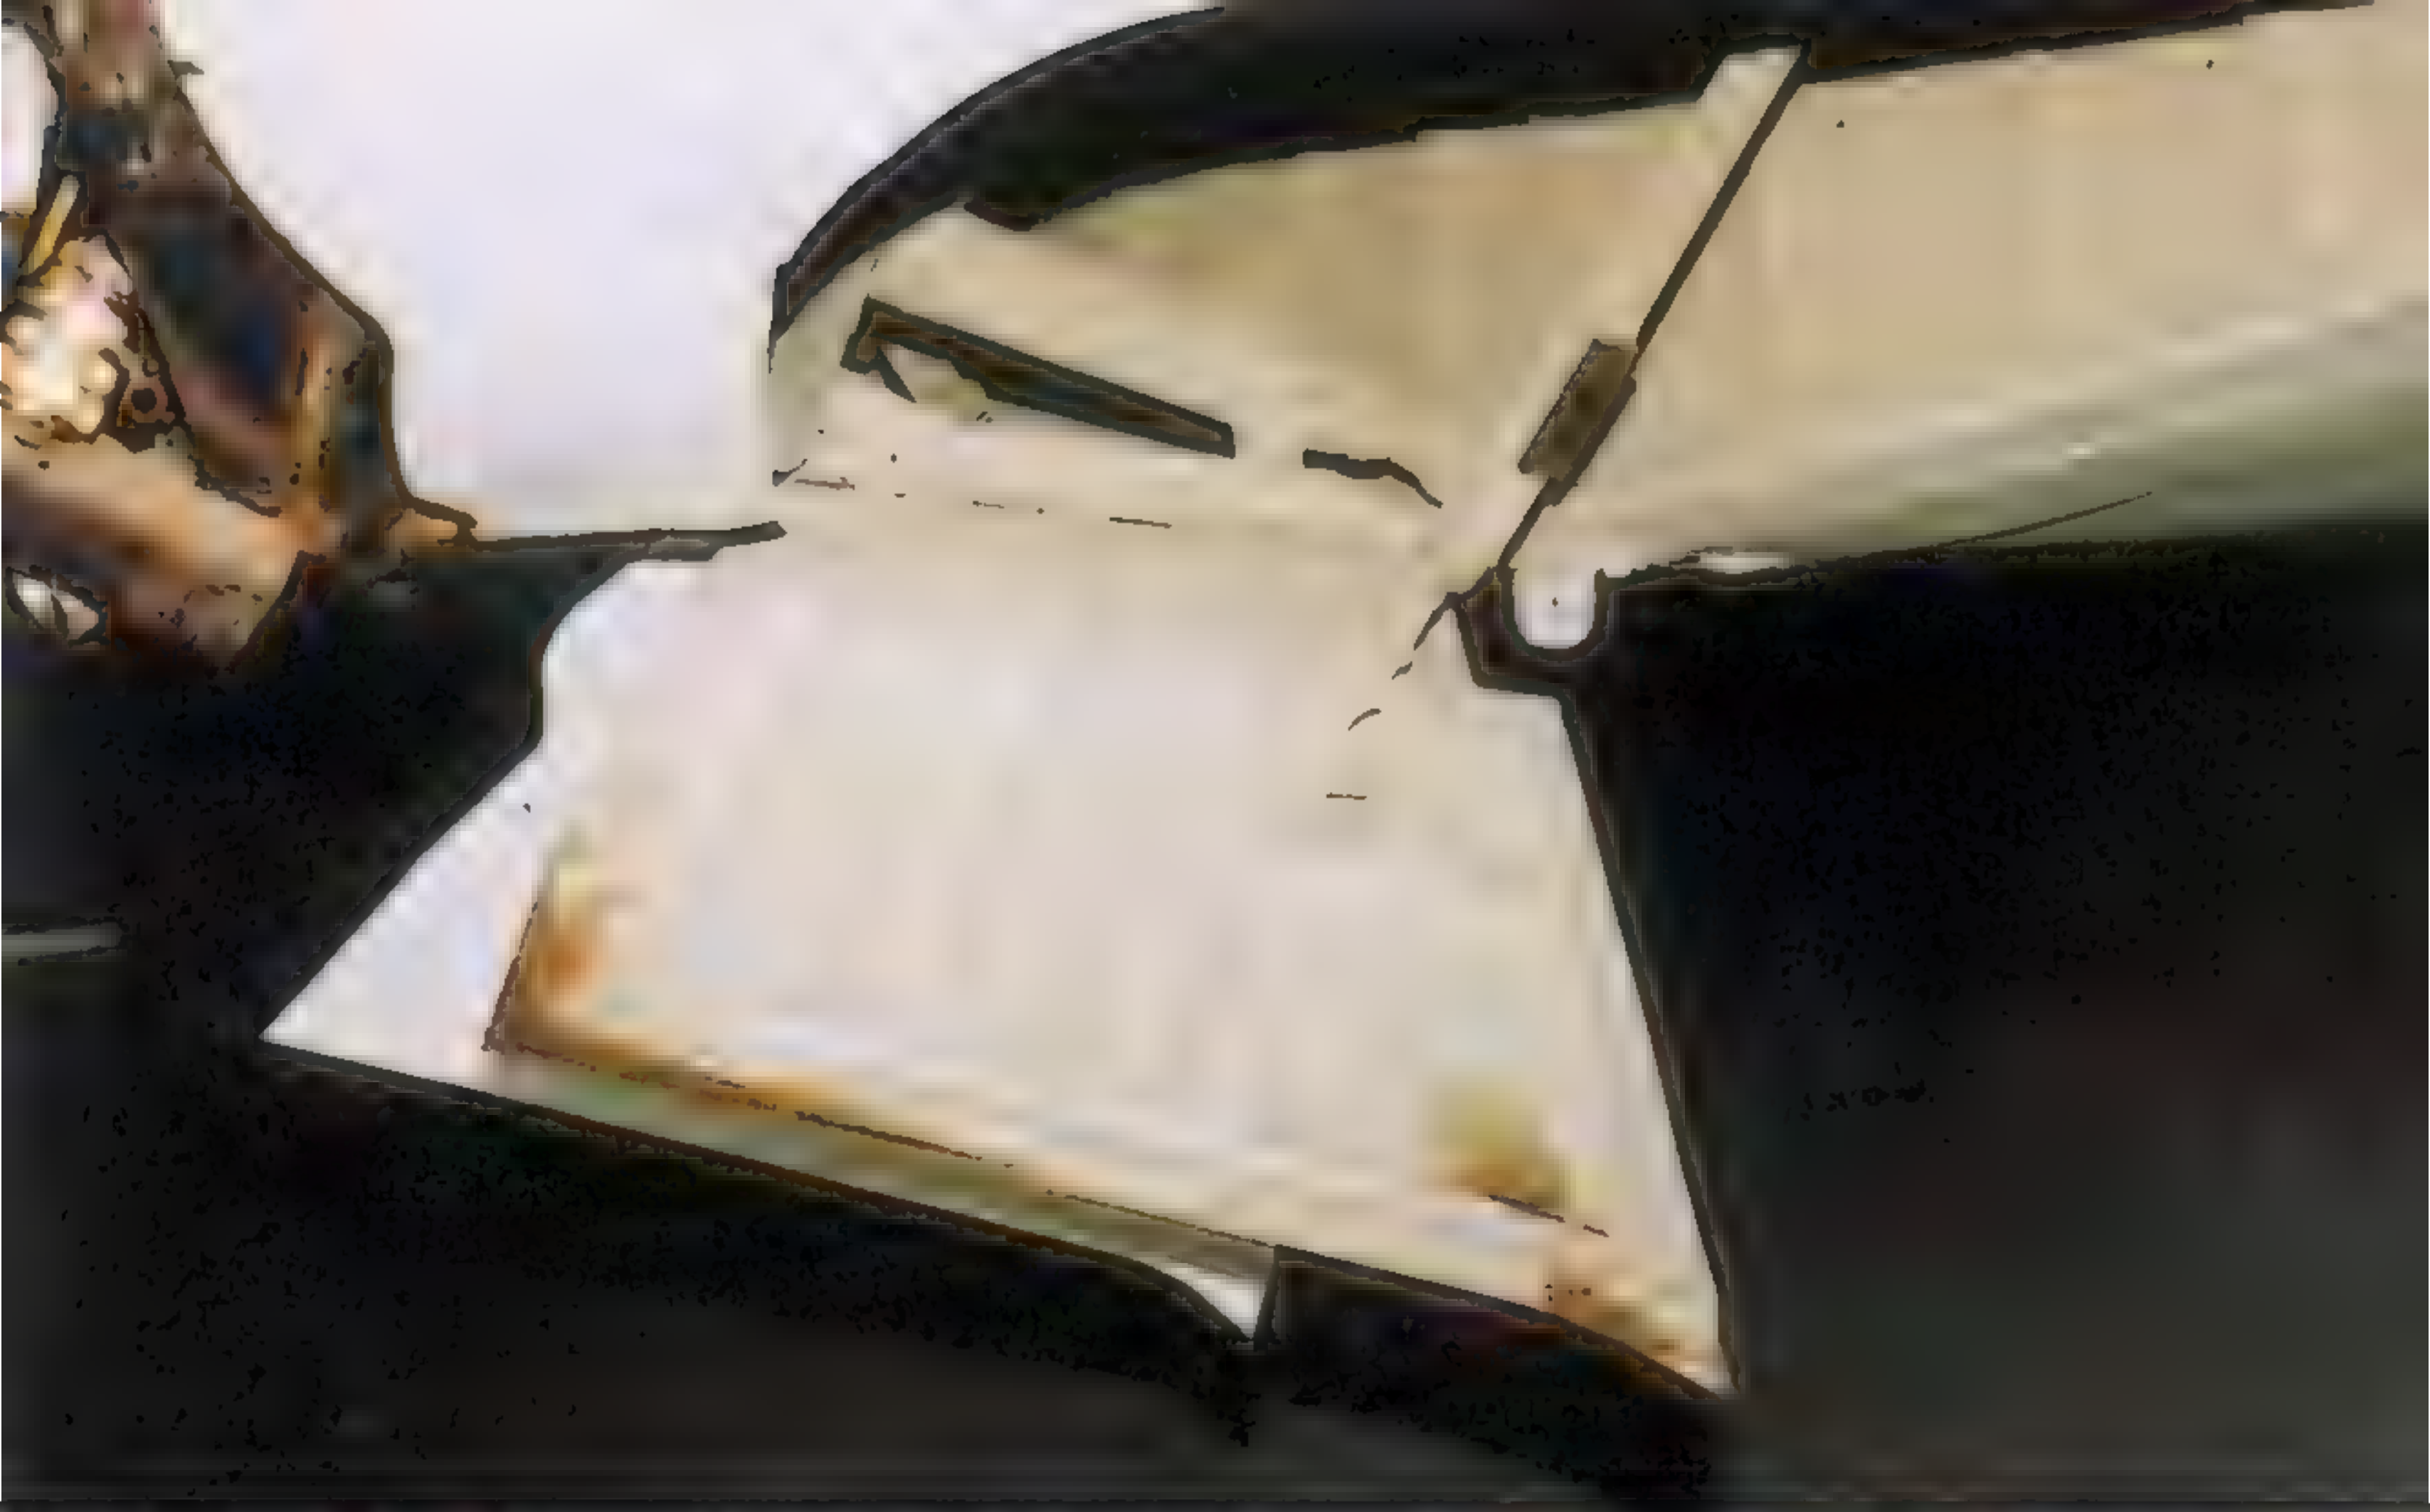
The inboard gear covers were closed by the retraction of the main landing gear. When retracted, the tire would contact the black striker plate on the wheel door upper strut. This caused the wheel door lower strut, which wrapped around the bottom of the tire, to pull the door closed. (Molnar & Hugo)

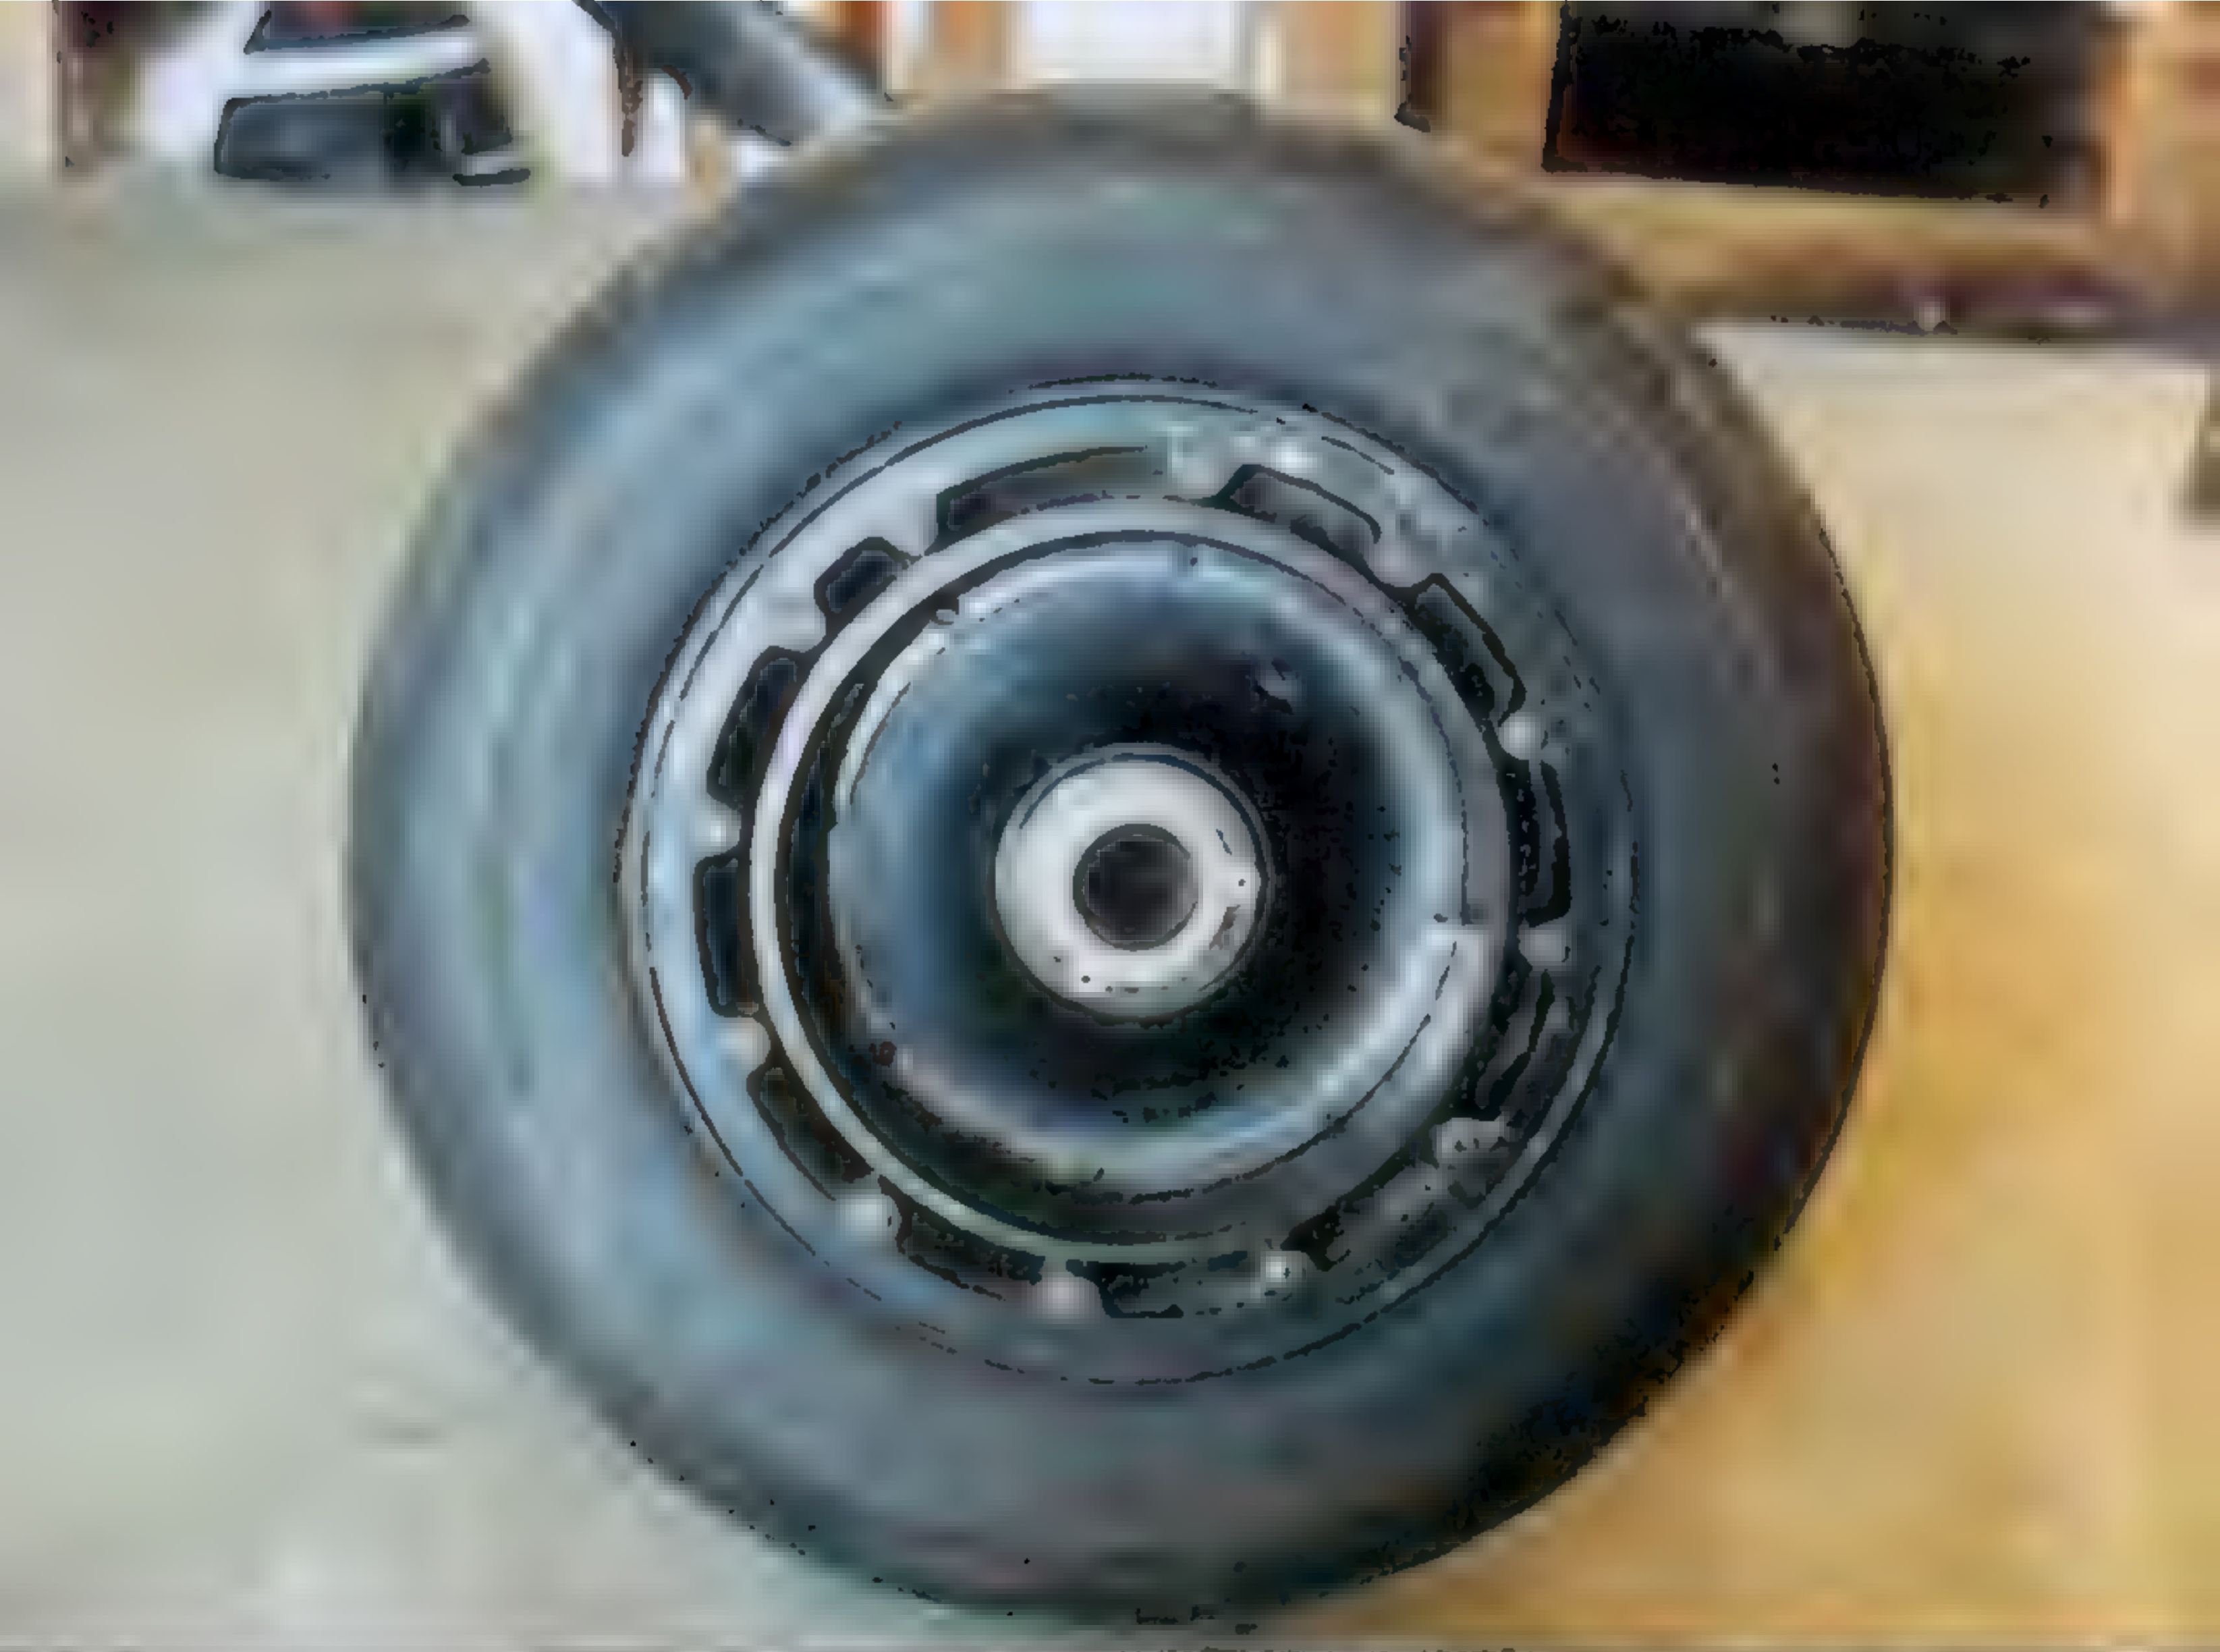
The main landing gear strut axle fit into the wheel hole. The Fw 190's main wheel tires measured 700 mm (27.6 inches) by 175 mm (6.9 inches) The wheel is painted RLM 66 Black Gray (FS36081). (Laing)

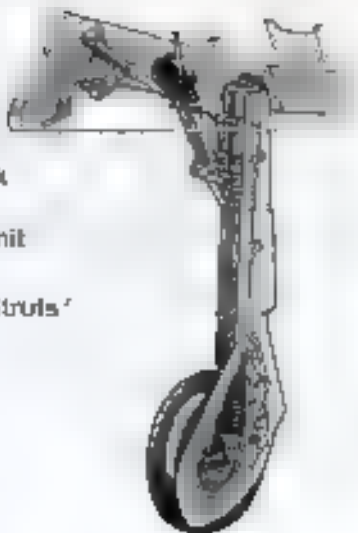
# Main Landing Gear

Sealed Air Jack

Rotating Drive Unit

Radius Struts

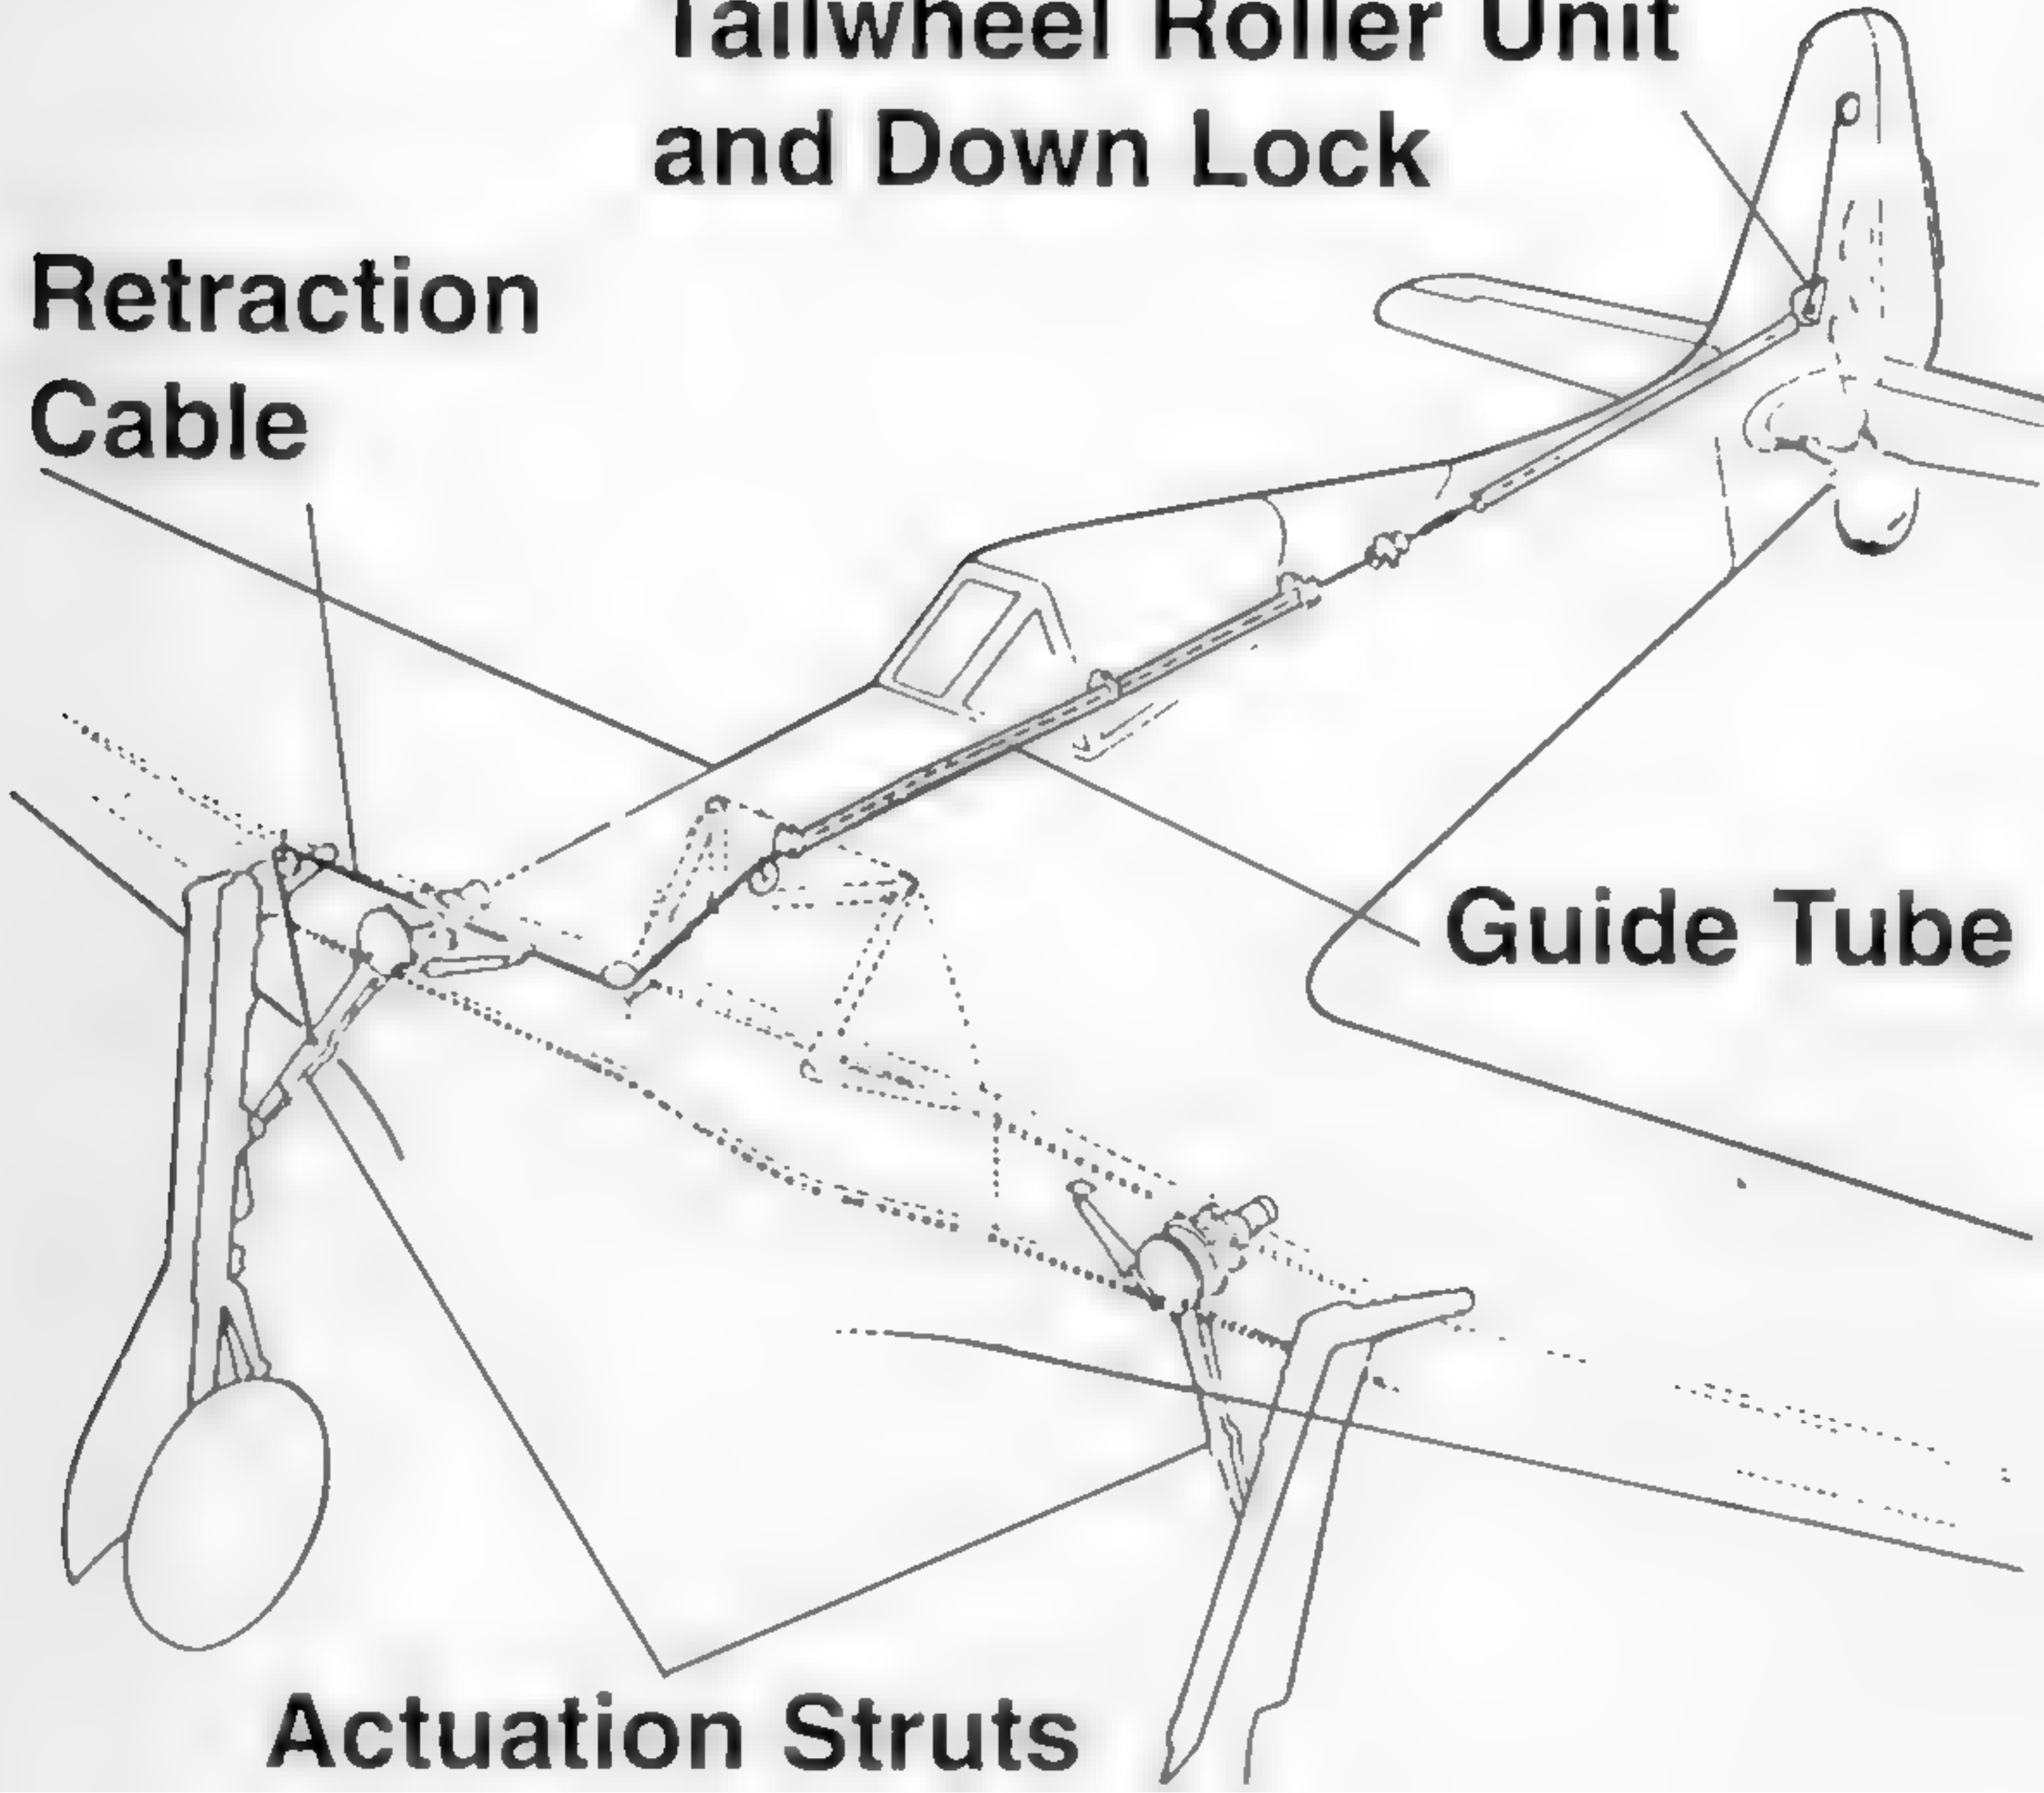
# Tailwheel Roller Unit and Down Lock

**Tailwheel Retraction  
System**

**Retraction  
Cable**

**Guide Tube**

**Actuation Struts**
